# GREENCASTING

## GREEN CASTING LIFE – Final Seminar: Sustainable Solutions for Foundries

ODLEWNIE POLSKIE S.A.

**Odlewnie Polskie S.A.  
flagship foundry in Poland**

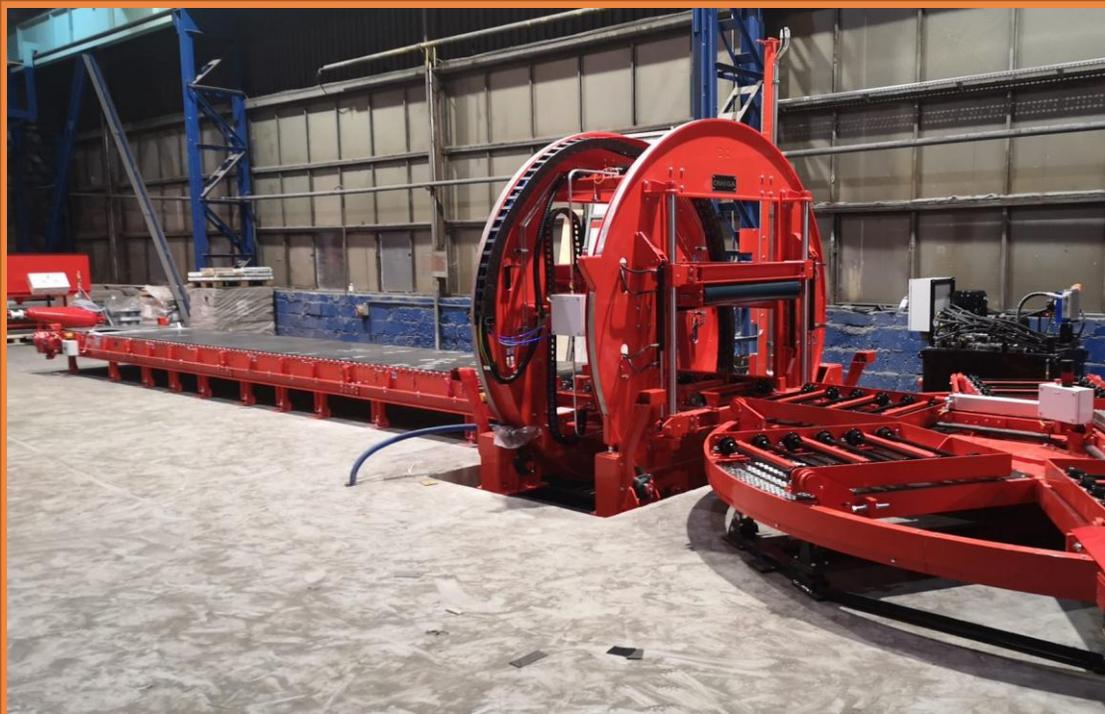
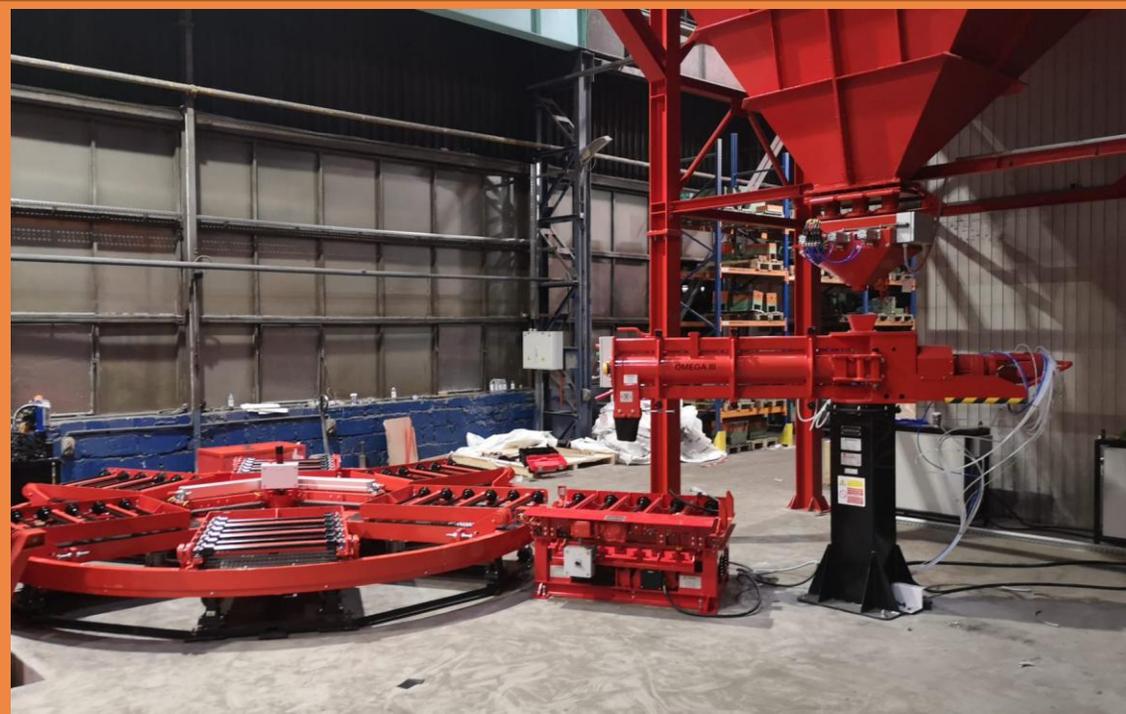
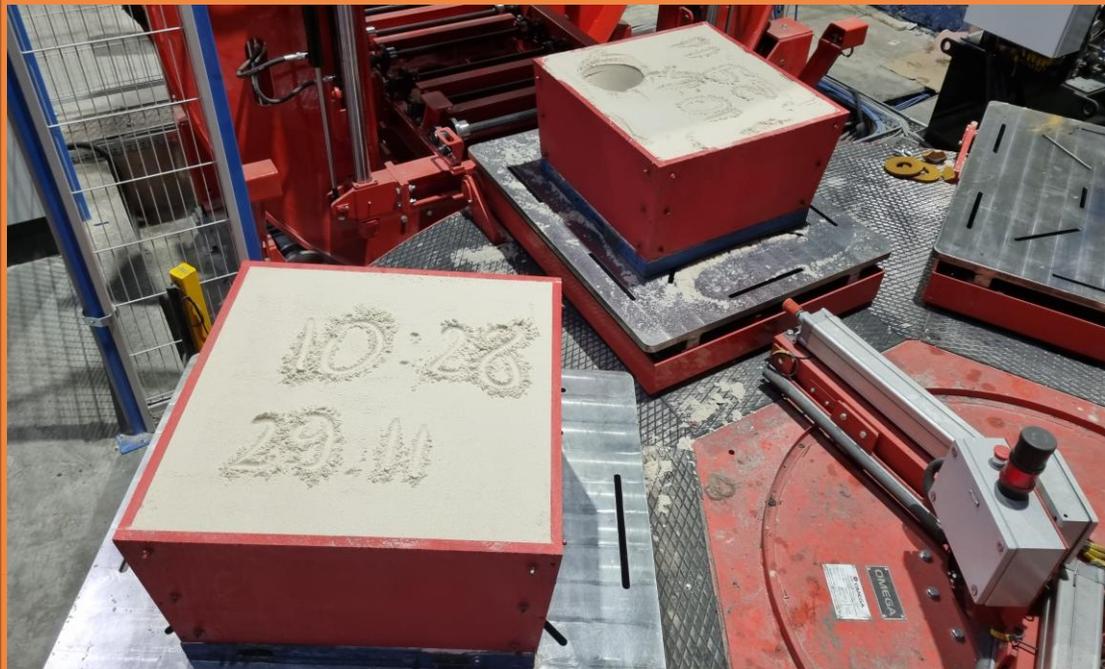
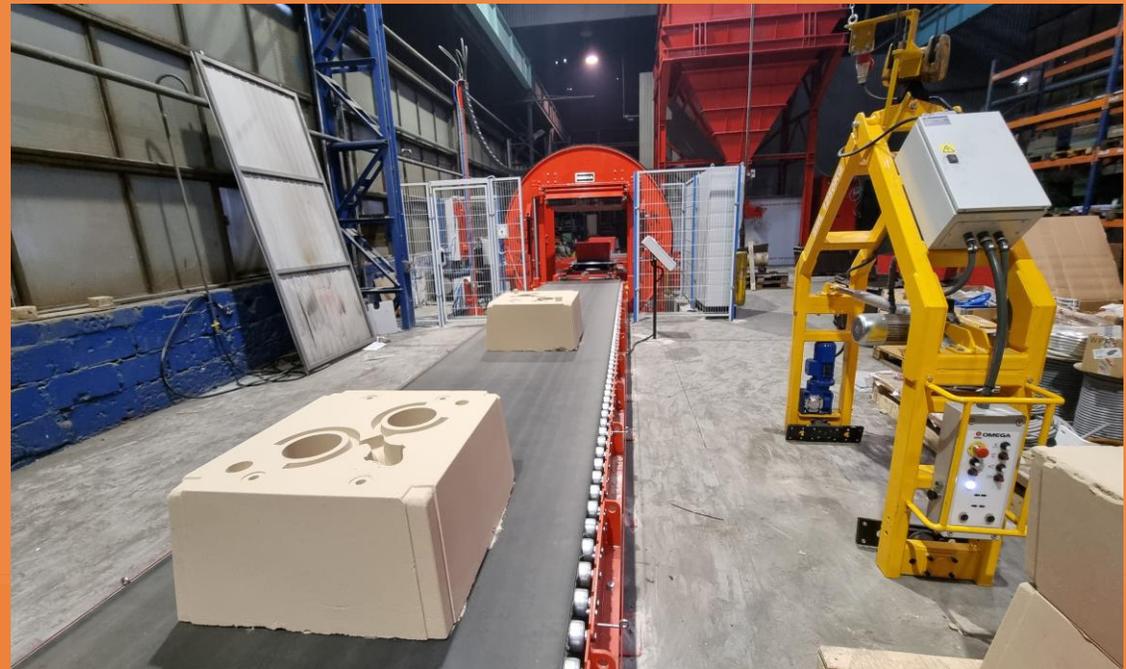
**Molding line**

# Instalation made in OPSA

1. New molding line dedicated to the inorganic technology, with mikser 10T/h.
2. New reclamation line dedicated to the inorganic technology.

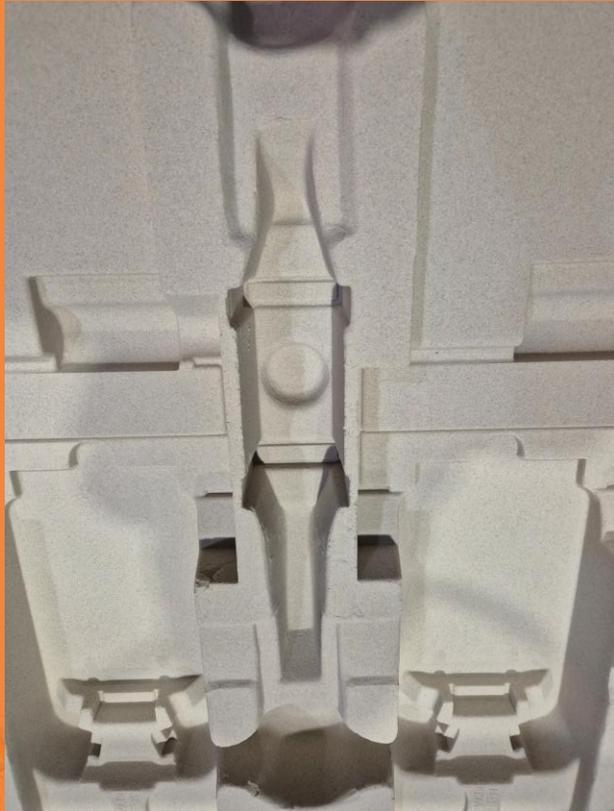
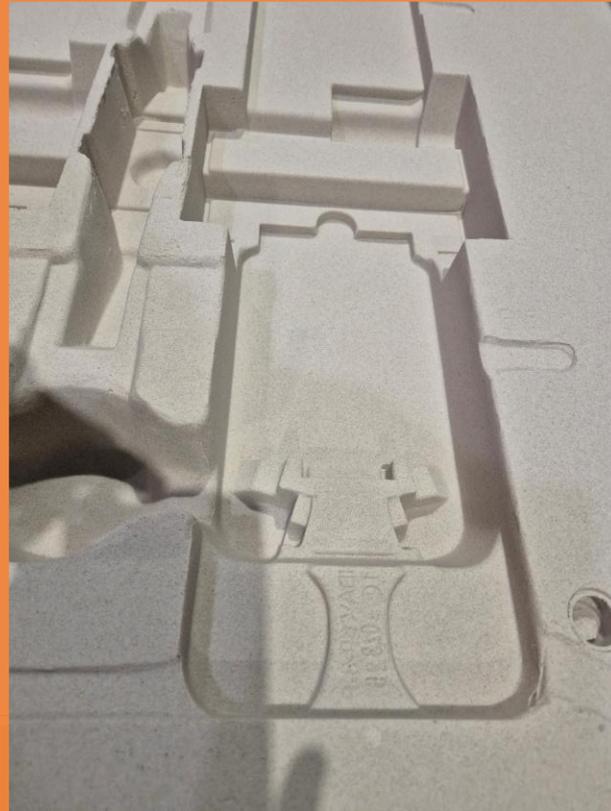
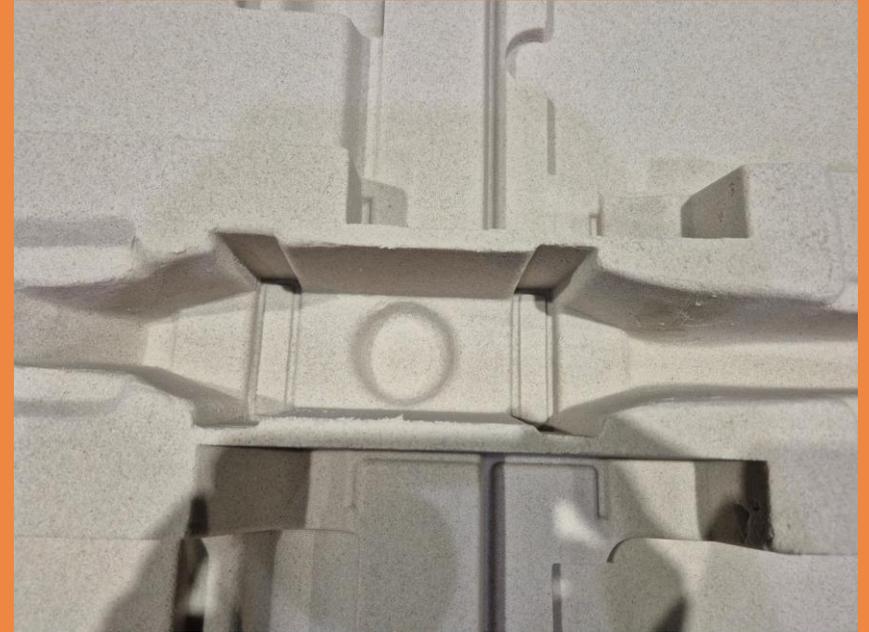
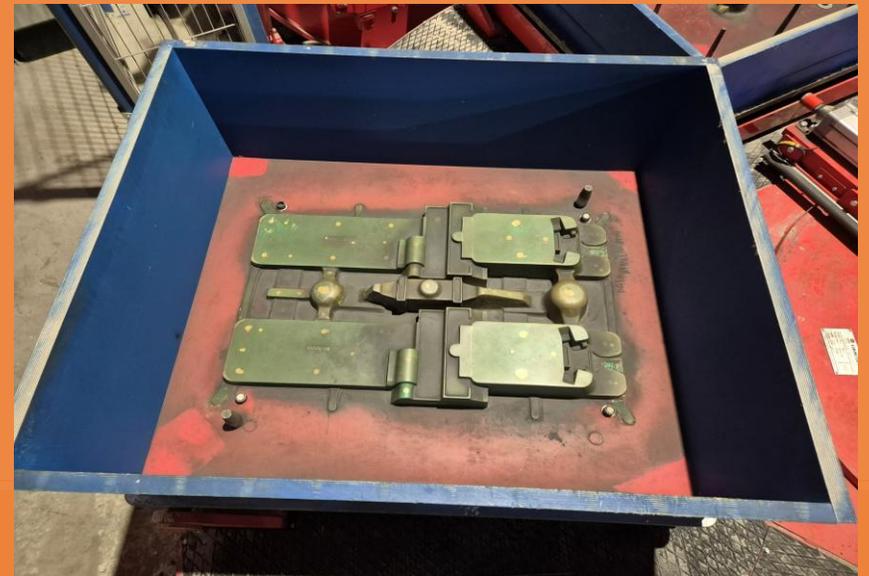
# Veryfication of material used for models and pattern plate.

Wood and resin -OK. It's possible to make the molds in low temp.

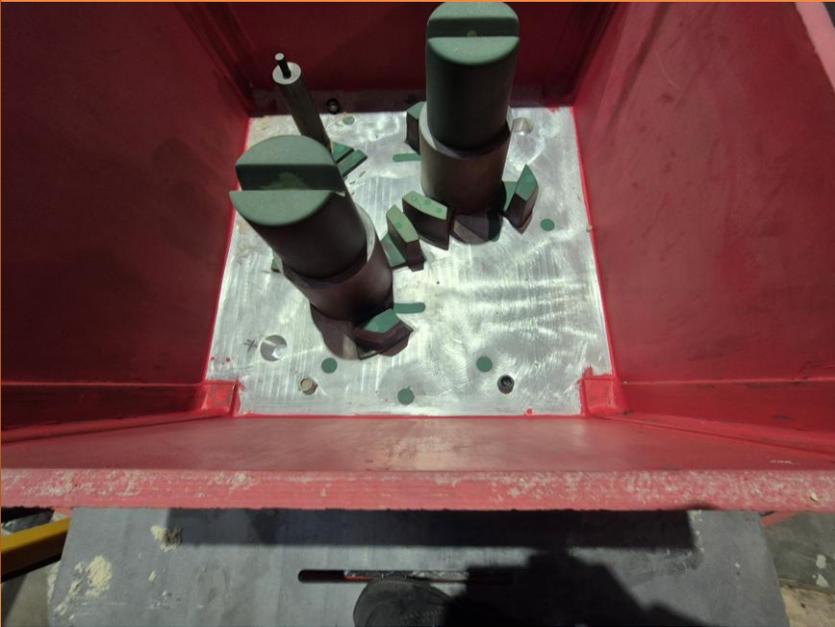
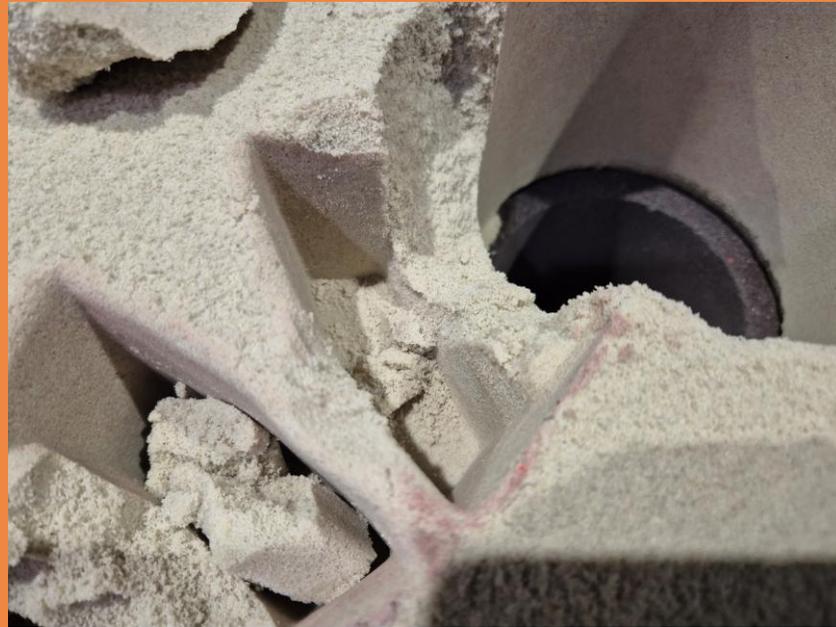
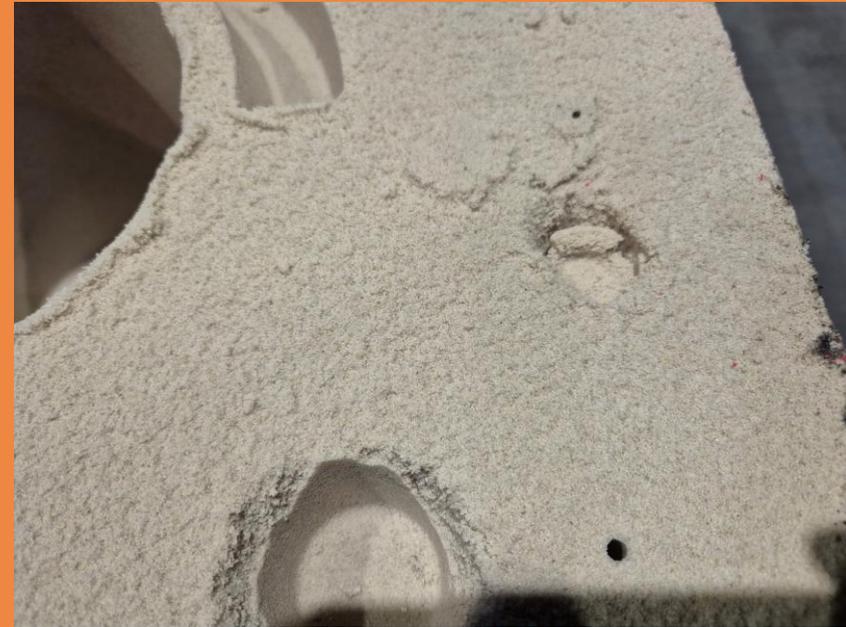
# Verification of material used for models and pattern plate.

Aluminium or steel it's NOK. With this material is not possible to make the molds in low temp. Even when pattern ware warmed.

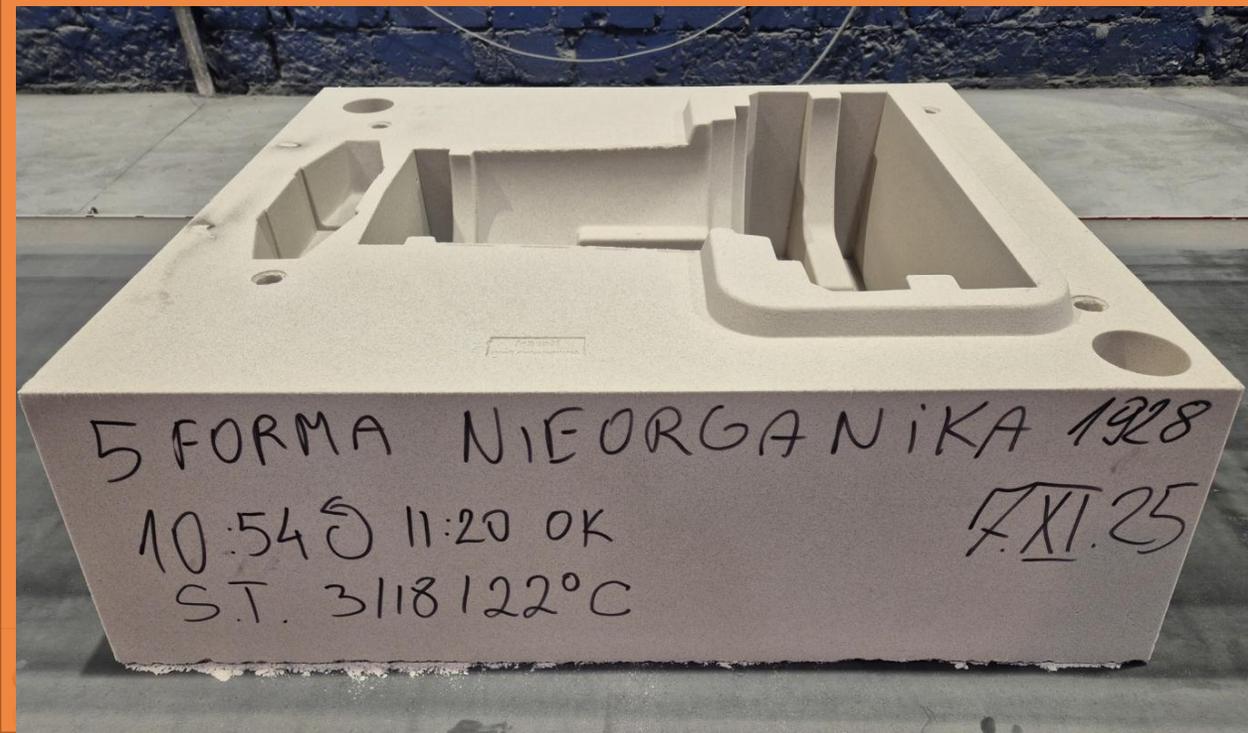
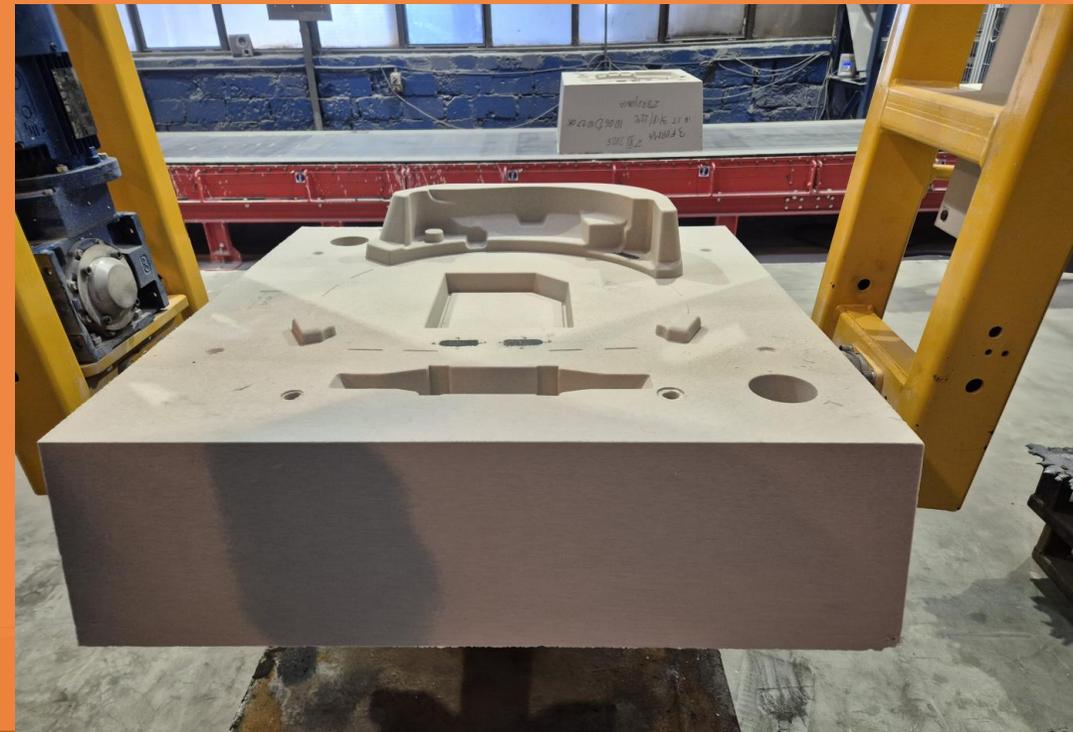
1. In OPSA for serial test we chose 3 types of parts (housing).
2. Test ware made in last month of 2025.
3. In all of the moulds we add reinforcement rod to compensate low strenght of the moulds. There was low air temperature 8 °C but sand temperature was 25°C. Results at next slide
4. We casted 15 moulds with out any leakage and other issue.
